Manhole Inspection Summary

Manhole # S45CC_049MH

Insp Date: **6/30/08 1:22 PM**

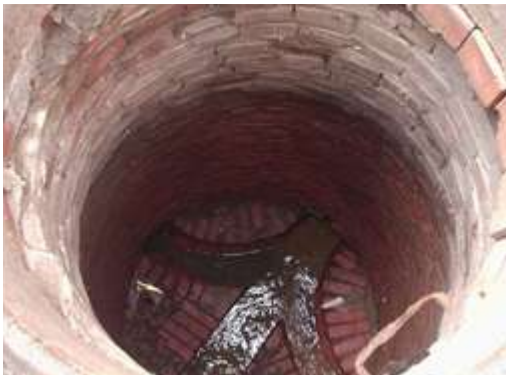
Defect 2

☒ **Leaks**

Frame Leaks

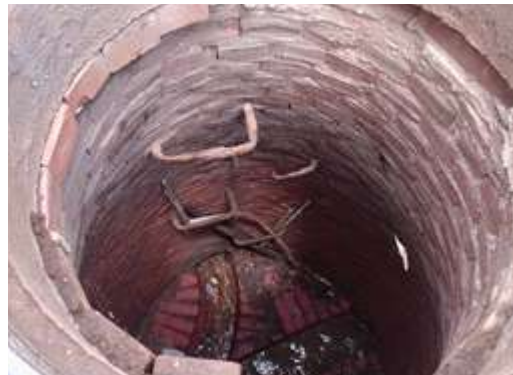
Defect 1

Condition: ☐ Sound ☐ Cracked ☐ Root Intrusion ☒ **Loose Brick** ☐ Deteriorated

Infiltration: ☐ None ☐ Joint ☐ Cracks ☒ **Mortar** ☐ Roots ☐ Wall

Loose Brick

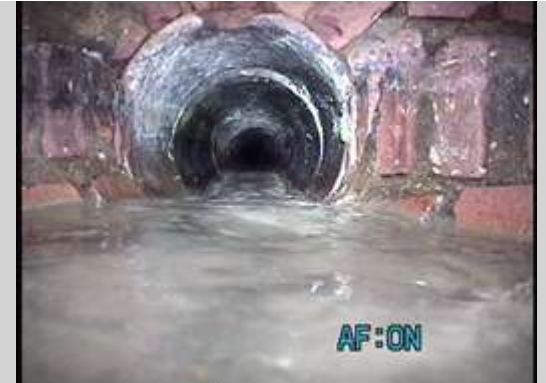
12 O'Clock Outflow

8 in. Circular Gravity Sewer
Pipe Out @ 12 O'Clock

Pipe Height: **8.4** (in.) Rod and Bar (Angled)
Pipe Material: **Clay** ☐ Pipe Lined
Invert Depth: **9.50** (ft.) Flow Characteristics: **Slow**
Deposits: ☒ None ☐ Mud ☐ Sludge ☐ Debris ☐ Grease
Silt Depth: (in.) Deposits Extent:
Infiltration: **None** Pipe Seal Cond: **Sound**

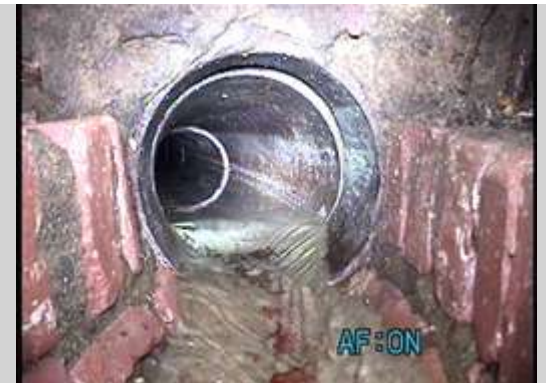
3 O'Clock Inflow

8 in. Circular Gravity Sewer
Pipe In @ 3 O'Clock

Pipe Height: **8.4** (in.) Rod and Bar (Angled)
Pipe Material: **Clay** ☐ Pipe Lined
Invert Depth: **9.40** (ft.) Flow Characteristics: **Slow**
Deposits: ☒ None ☐ Mud ☐ Sludge ☐ Debris ☐ Grease
Silt Depth: (in.) Deposits Extent:
Infiltration: **None** Pipe Seal Cond: **Sound**

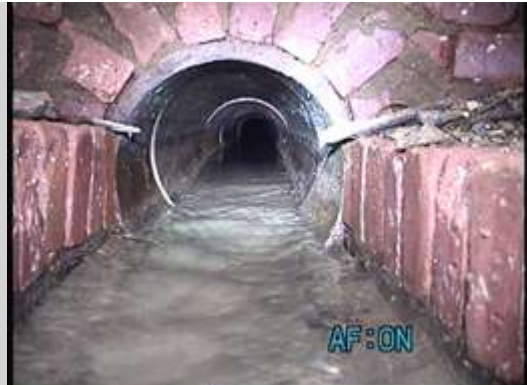
6 O'Clock Inflow

Infiltration: **None** Pipe Seal Cond: **Sound**

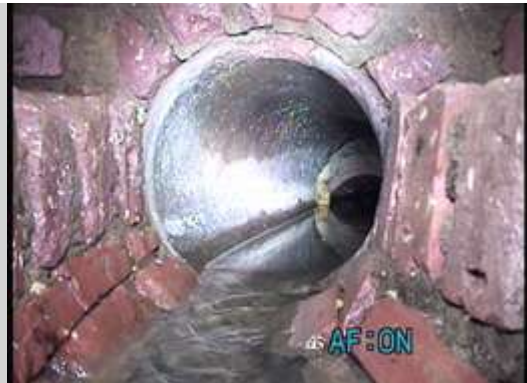
9 O'Clock Inflow

Infiltration: **None** Pipe Seal Cond: **Sound**
